Report on  
Preliminary Site Investigation (Contamination)

Proposed Rezoning  
Sub-Precinct 5, South Creek West, NSW

Project 92225.04  
June 2022

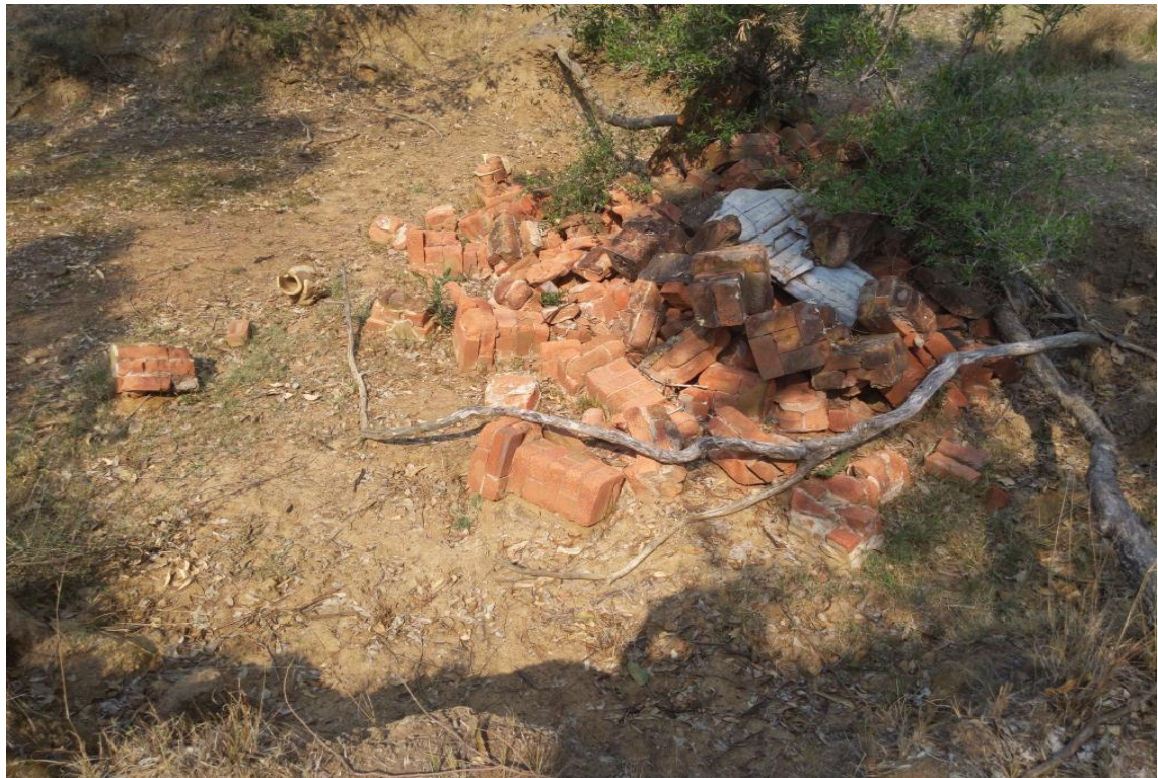
- Numerous timber power poles were observed across the site;
- Evidence of fly tipping and/or filling (potential asbestos pipe and bricks) within a drainage line in the north-east portion of the property described as Part Lot 500 DP 1231858; and
- Fragments of brick and building materials on the slope to the north of the residence on the property described as Lot 4 DP 1216380 – Metromap imagery from 2009, which shows several dozen stockpiles with an approximate combined footprint of 190 m<sup>2</sup>. It is unclear if the stockpiles were removed or spread across site prior to becoming grassed over.

Photo 4 - Observed Fly Tipping

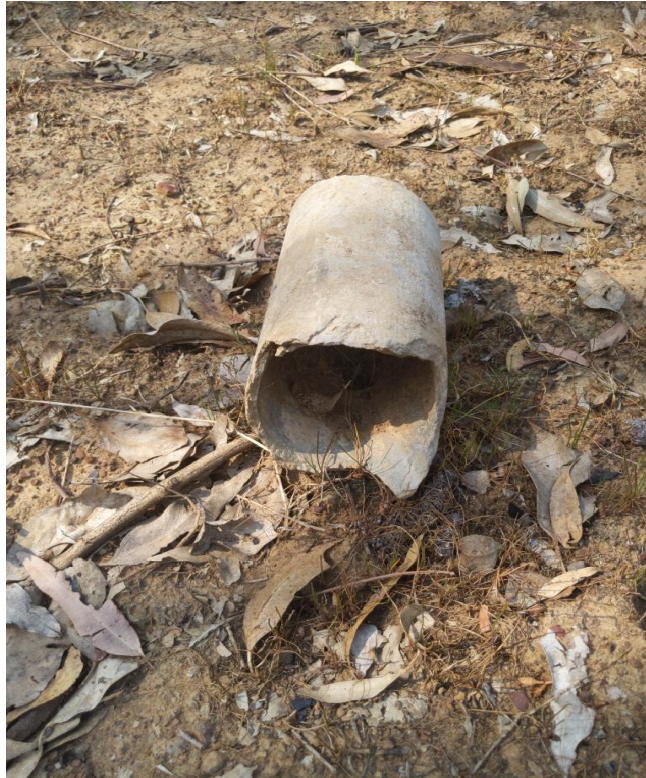
Photo 5 - Potential ACM Pipe
