Boyuan Bringelly Pty Ltd  
Level 6, 5 Martin Place  
SYDNEY NSW 2000

Project 92225.04  
17 June 2022  
R.002.Rev2  
LOC

**Preliminary Groundwater Investigation  
Proposed Rezoning  
621 - 705 The Northern Road, Cobbitty, NSW**

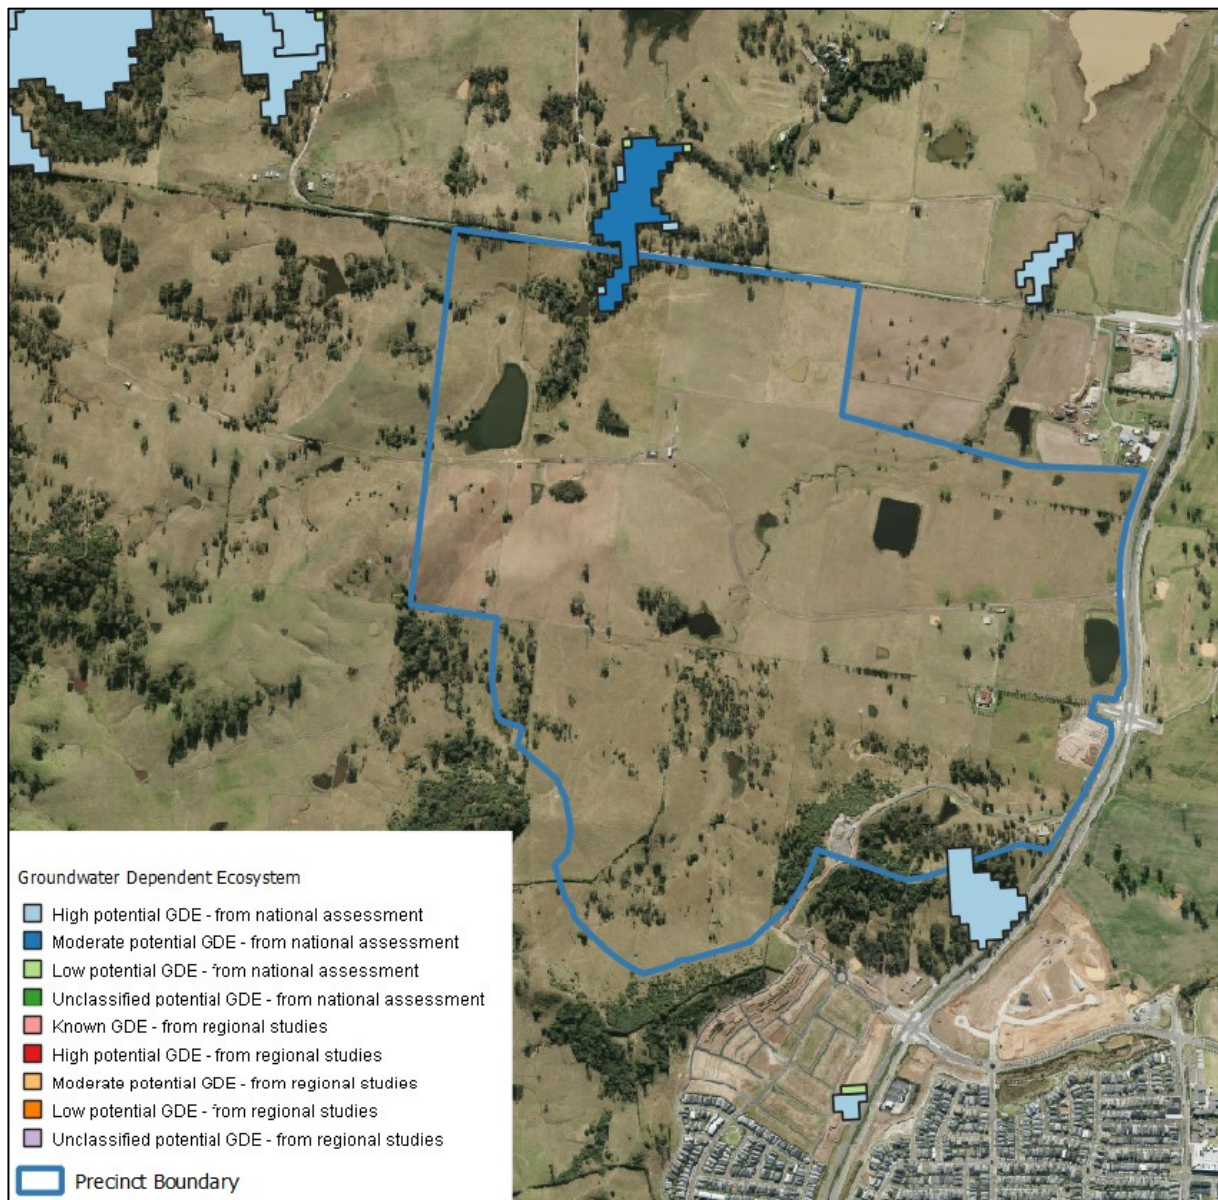
**Figure 1: GDE in close proximity to the site**

Review of the *Groundwater Dependant Ecosystem Atlas* (BOM, 2020) did identify a Groundwater Dependant Ecosystem (GDE) of Cumberland Shale Hills Woodland and Cumberland River Flat Forest marginally within the southern boundary and northern boundary of the site, respectively (as shown on Figure 1 below). Groundwater at the site is inferred to generally flow towards the north, and therefore is unlikely to impact on the GDE. To the north of the site, GDEs of Cumberland Shale Hills Woodland and Cumberland River Flat Forest were identified approximately between 400 m to 900 m from the site boundary and were associated with creeks and drainage lines. As stormwater will be directed toward

these areas as part of development, it is not considered likely that there will be any impact from development with suitable controls.

The GDEs to the north of the site were associated with creeks and drainage lines. As stormwater will be directed toward these areas as part of development, it is not considered likely that there will be any impact from development. The GDE to the south is inferred to be in a separate groundwater catchment to the majority of the site and is unlikely to be impacted by the current development.

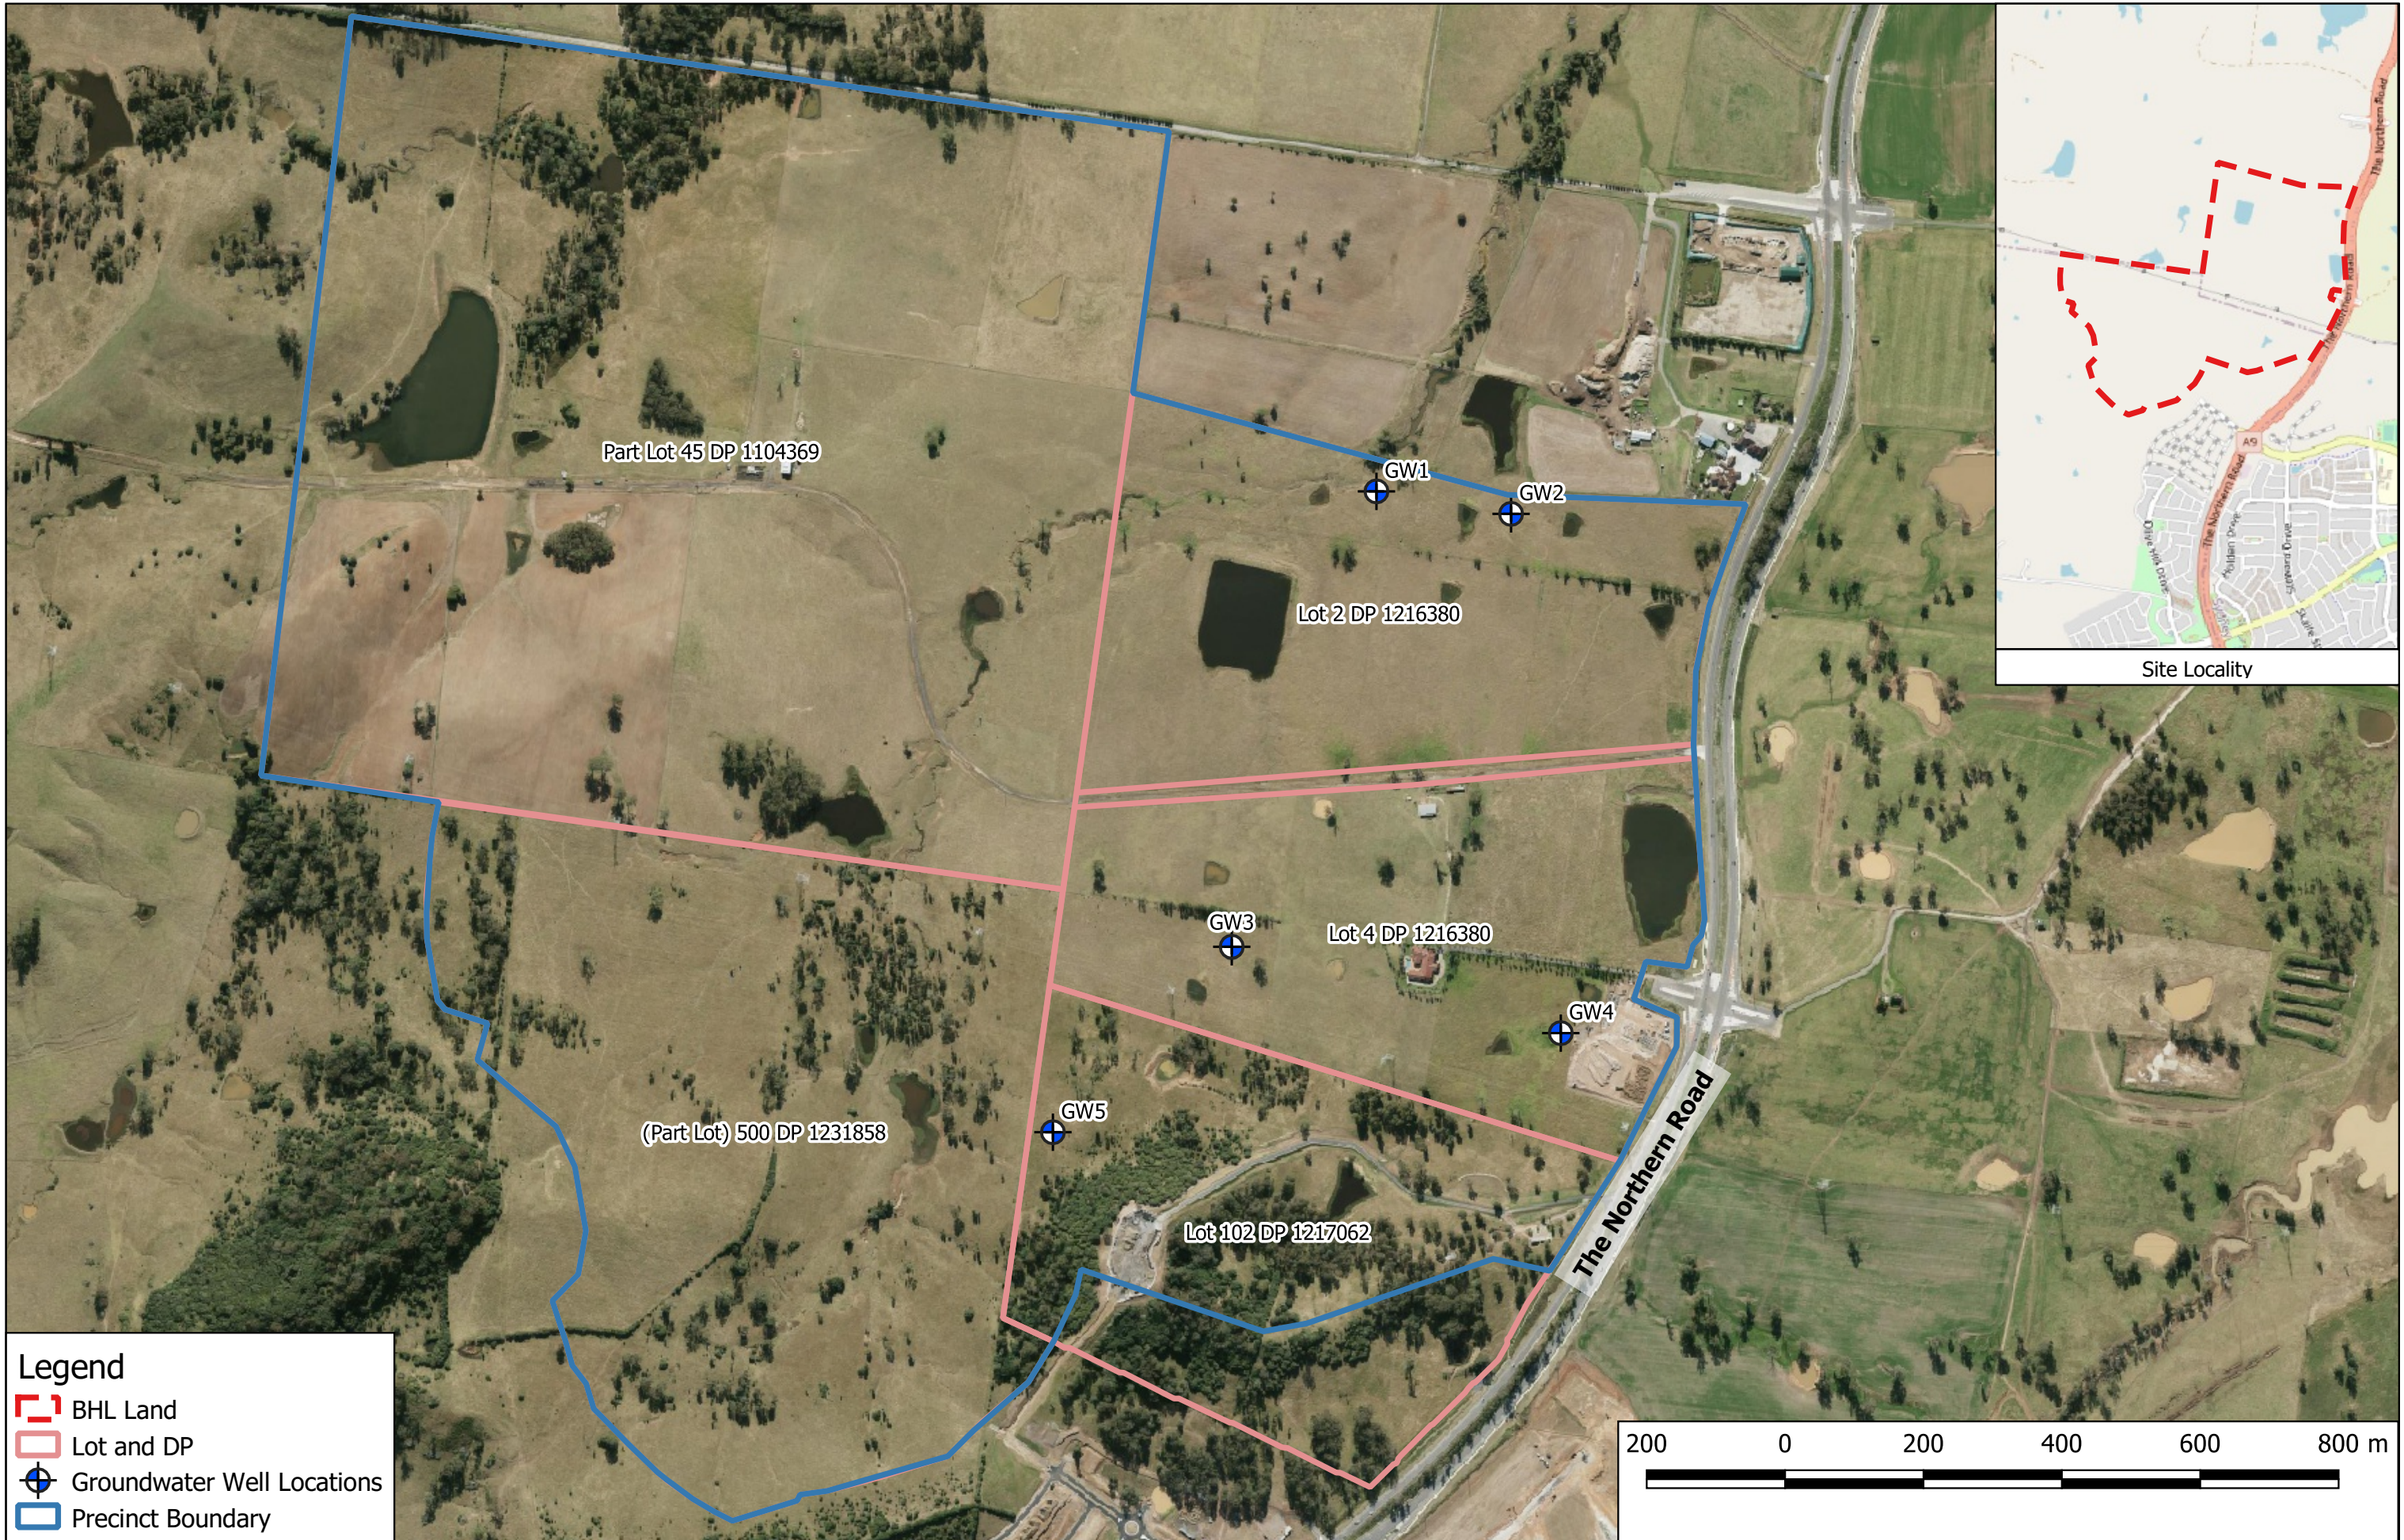
Douglas Partners Pty Ltd (DP) were commissioned by Boyuan Bringelly Pty Ltd to conduct a preliminary groundwater investigation at 621 – 705 The Northern Road, Cobbitty (the site). The site location is shown on Drawing 1, attached.

It is noted that the conclusions of this groundwater investigation were based on a previous Indicative Layout which considered the entirety of Sub-Precinct 5. The current ILP only incorporates Lots 2 & 4 in DP 1216380, Lot 2 in DP 1241819 and Lot 500 in DP 1231858 as shown in Drawing 1.

The locations of the boreholes are shown on Drawing 1, attached. The borehole logs, including the construction details of the wells, are attached, together with notes defining classification methods and descriptive terms.
